**Flood Control Project Maintenance  
Levee Inspections**

**Fall 2012 Levee Maintenance Deficiency Summary Report**

**Flood Control Project Maintenance  
Levee Inspections  
LMA District Cover Sheet  
Fall 2012 Levee Inspection Results**

**Reclamation District No. 0003 Grand Island**

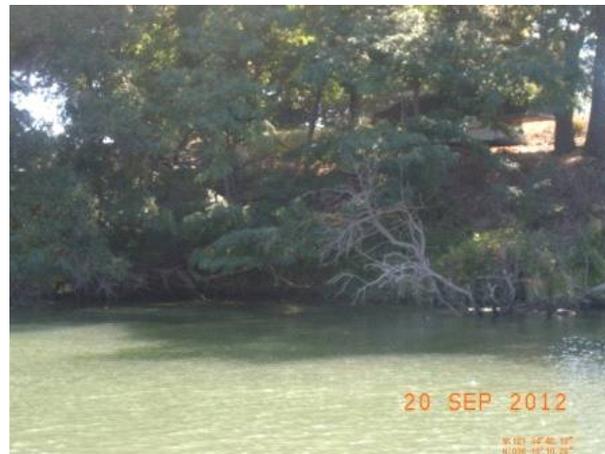
Levee Mile Report Line	6
Start Levee Mile	0.21
End Levee Mile	0.21
Location	Water Side
Category	Earthen Levee
Item	Encroachments
Looking southwest at trash on waterside berm.	
richard_f_20121012_371.jpg

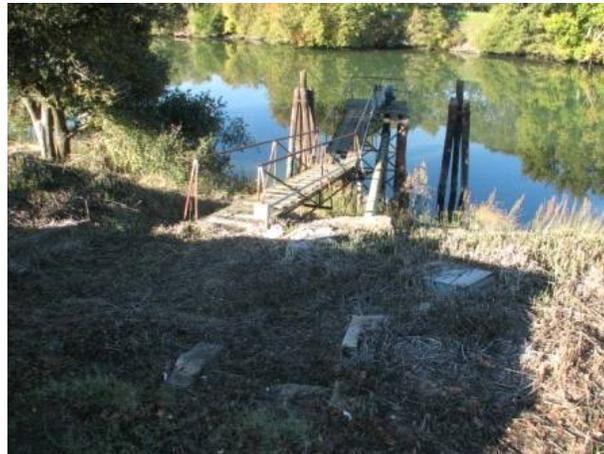
Levee Mile Report Line	18
Start Levee Mile	1.40
End Levee Mile	1.40
Location	Land Side
Category	Earthen Levee
Item	Encroachments
Equipment within 10' of levee toe obstructs access and visibility.	
richard_f_20121012_349.jpg

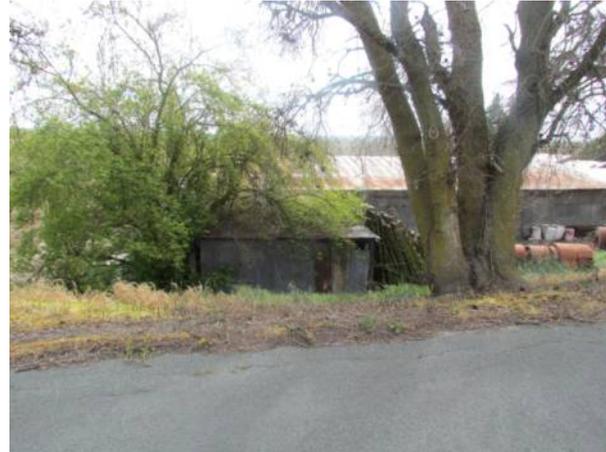
Levee Mile Report Line	19
Start Levee Mile	1.60
End Levee Mile	1.60
Location	Land Side
Category	Earthen Levee
Item	Vegetation
Looking southeast at dense trees on landside shoulder and slope.	
richard_f_20121012_333.jpg

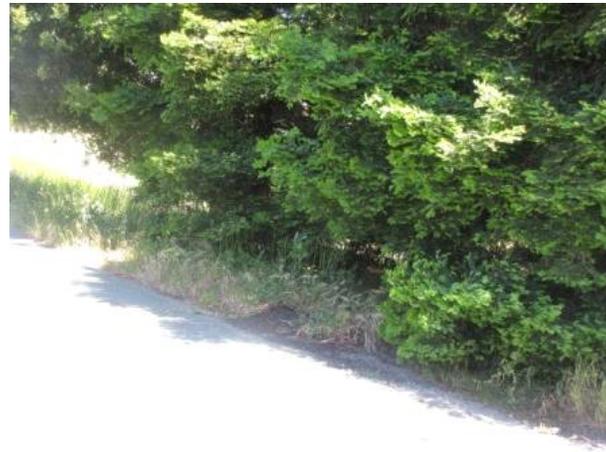
Levee Mile Report Line	19
Start Levee Mile	1.60
End Levee Mile	1.60
Location	Land Side
Category	Earthen Levee
Item	Vegetation
Looking southeast at dense trees on landside shoulder and slope. (updated Spring 2012)	
richard_f_20121012_334.jpg

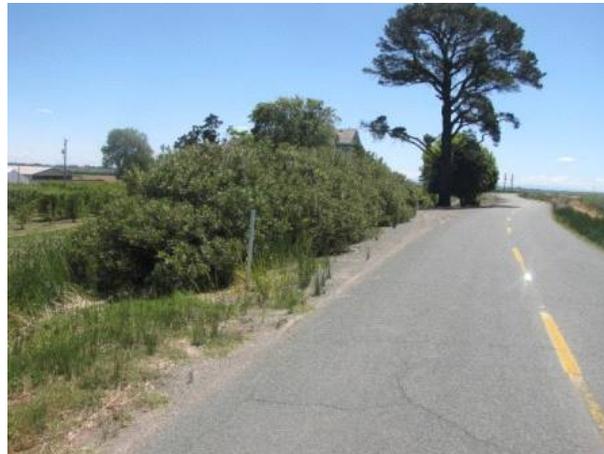
Levee Mile Report Line	37
Start Levee Mile	3.33
End Levee Mile	3.33
Location	Land Side
Category	Earthen Levee
Item	Vegetation
Large cactus on upper levee slope obstructs access and visibility.	
richard_f_20121012_354.jpg

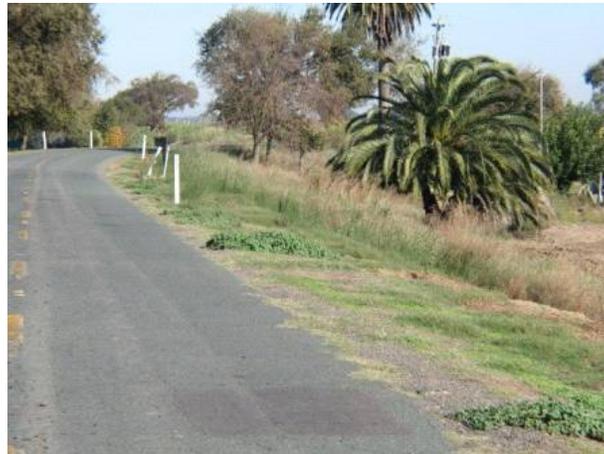
Levee Mile Report Line	48
Start Levee Mile	5.33
End Levee Mile	5.33
Location	Land Side
Category	Earthen Levee
Item	Vegetation
Looking west a century plants on landside slope next to a ramp.	
richard_f_20121012_357.jpg

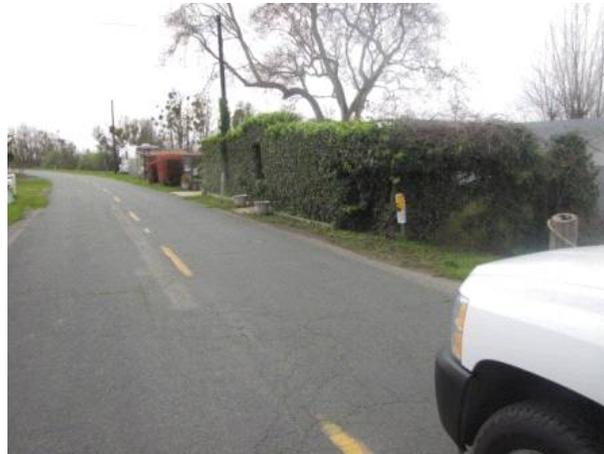
Levee Mile Report Line	66
Start Levee Mile	7.69
End Levee Mile	7.69
Location	Land Side
Category	Earthen Levee
Item	Encroachments
Buildings obstruct access and visibility of levee slope and toe.	
richard_f_20121012_363.jpg

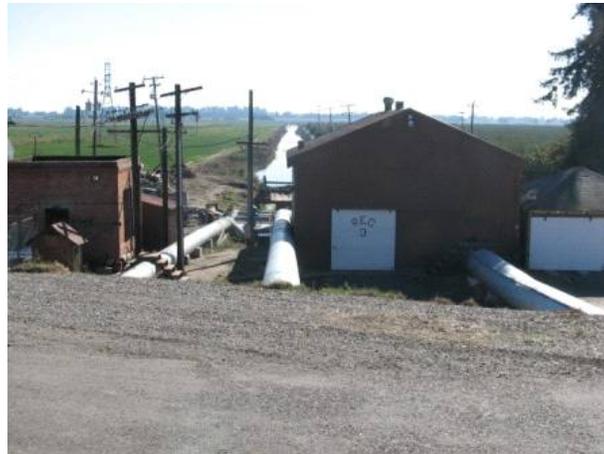
Levee Mile Report Line	83
Start Levee Mile	9.19
End Levee Mile	9.19
Location	Water Side
Category	Earthen Levee
Item	Erosion / Bank Caving
Erosion occurring around pipe penetration.	
richard_f_20121012_368.jpg

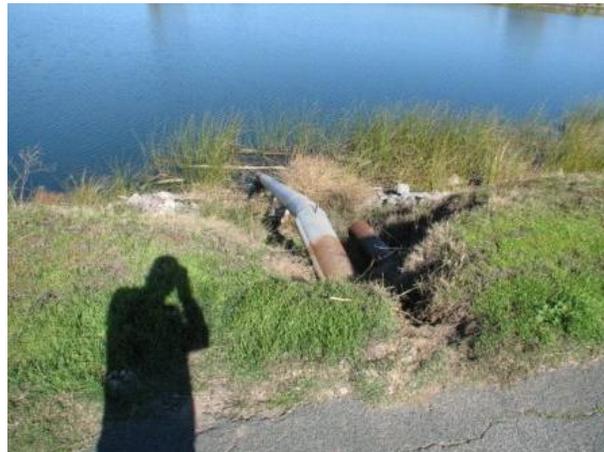
Levee Mile Report Line	83
Start Levee Mile	9.19
End Levee Mile	9.19
Location	Water Side
Category	Earthen Levee
Item	Erosion / Bank Caving
Looking west at repaired erosion around irrigation pipe.	
richard_f_20121012_369.jpg

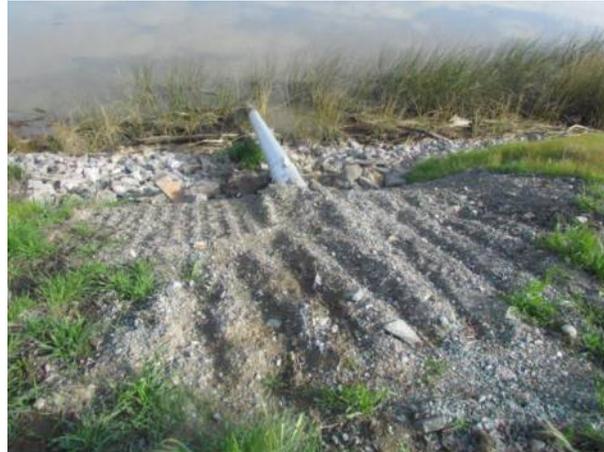
Levee Mile Report Line	84
Start Levee Mile	9.19
End Levee Mile	9.19
Location	Water Side
Category	Earthen Levee
Item	Encroachments
Pipe penetration showing newer pipe next to abandoned pipe.	
richard_f_20121012_367.jpg

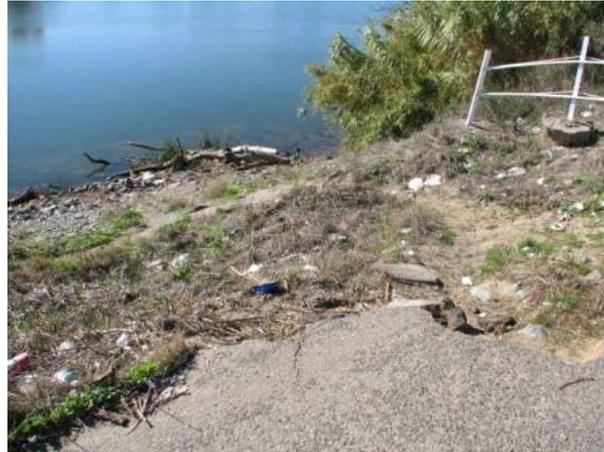
Levee Mile Report Line	5
Start Levee Mile	0.40
End Levee Mile	0.40
Location	Water Side
Category	Earthen Levee
Item	Slope Stability
Looking east at repaired slope damage caused by foot traffic.	
richard_f_20121012_375.jpg

DWR ID: DWR_RD0003_02_s_2012_5									
5	0.40	0.40	Earthen Levee	Slope Stability	WSA/W Ma	S2 : Repair the levee slope damaged by foot traffic and prevent access where possible. Inspector Comments: District repaired slope damage cause by foot traffic.	38.173989 ° -121.647142 °	38.173989 ° -121.647142 °	1 Y
DWR ID: DWR_RD0003_02_s_2012_1									
6	1.32	1.32	Earthen Levee	Encroachments	WSA/W Ma	PI : Pipe	38.171005 ° -121.631524 °	38.171005 ° -121.631524 °	39
DWR ID: DWR_RD0003_02_s_2012_39									
7	1.71	1.71	Earthen Levee	Encroachments	WSA/W Ma	PI : Pipe	38.167958 ° -121.625706 °	38.167958 ° -121.625706 °	40
DWR ID: DWR_RD0003_02_s_2012_40									
8	1.93	1.98	Earthen Levee	Vegetation	WS U En	V6 : Landscaping	38.166525 ° -121.622201 °	38.166176 ° -121.621332 °	70 Y
DWR ID: DWR_RD0003_02_s_2012_70									
9	2.50	2.50	Earthen Levee	Trim / Thin Trees	LS A/W Ma	T1 : Trim trees to at least five feet above ground level.	38.164369 ° -121.612548 °	38.164369 ° -121.612548 °	6

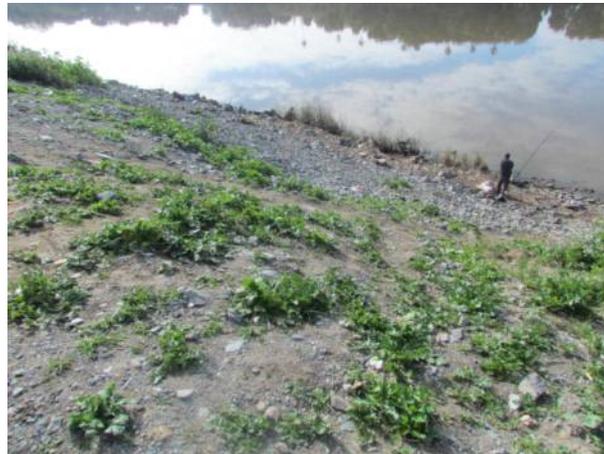
Levee Mile Report Line	8
Start Levee Mile	1.93
End Levee Mile	1.98
Location	Water Side
Category	Earthen Levee
Item	Vegetation
Landscaping on levee slope obstructs visibility and access.	
richard_f_20121012_409.jpg

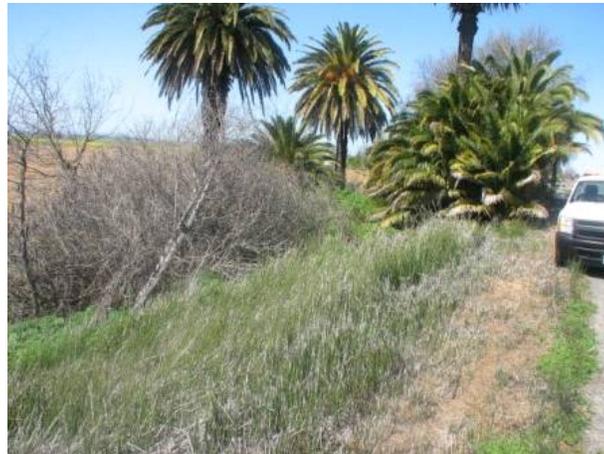
Levee Mile Report Line	34
Start Levee Mile	7.02
End Levee Mile	7.04
Location	Land Side
Category	Earthen Levee
Item	Vegetation
Front view of palm trees on landside shoulder	
richard_f_20121012_385.jpg

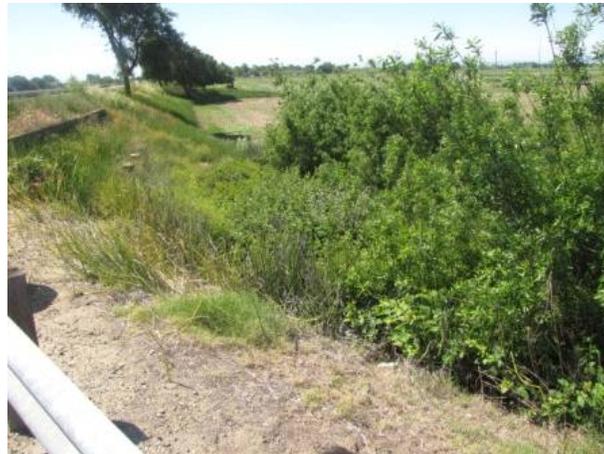
Levee Mile Report Line	36
Start Levee Mile	7.38
End Levee Mile	7.38
Location	Land Side
Category	Earthen Levee
Item	Vegetation
Looking northwest a dense landscaping on landside shoulder and slope.	
richard_f_20121012_402.jpg
